CASE STUDY

SIMPLE SOLUTION CURES REPEAT PUMP SHAFT BREAKAGES AT OIL REFINERY

- Cause of premature failures identified
- Solution required no modification to pump
- Improved MTBR

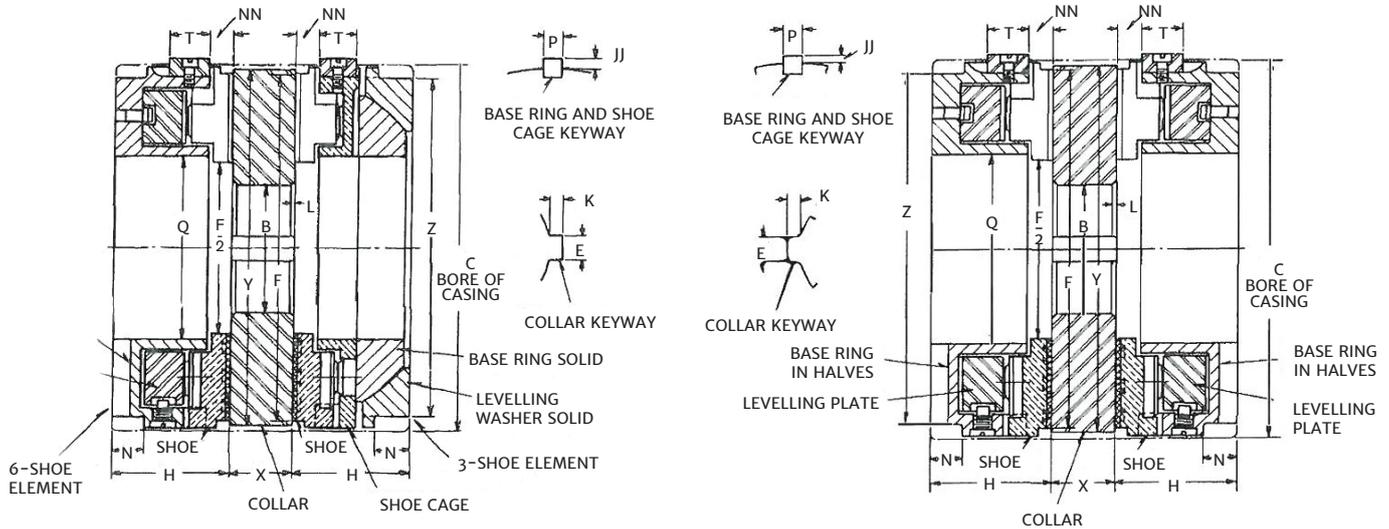
Thrust shaft breakages can occur for a number of reasons: improper shaft design, excessive thrust loading, excessive runout of the shaft and/or thrust collar, or poor materials specification. In this instance, the intrinsic design was the root cause. The internal levelling washer had seized, forcing the thrust collar to cycle the shaft until it failed.

Bearing Number	JHN-7
3-Shoe Element Area (Net Sq. In.)	12.3
6-Shoe Element Area (Net Sq. In.)	24.5
JHN Bearing, complete	43
Spare Collar	12 1/2
6 Spare Shoes	6
B (Bore)*	2.500
C	7.375
E	1/2
F (Normal Size)*	7
H	2 3/8
JJ	3/16
K	1/4
L (Chamfer)	1/16
N	3/8
NN	7/16
P	3/8
Q	3 3/4
T	13/16
X	1 1/4
Y	7 1/8
Z	6 7/8

Bearing Number	JHJ-7
Area (Net Sq. In.)	24.5
J H Bearing, complete	30
JHJ Bearing, complete	47
Spare Collar	12 1/2
6 Spare Shoes	6
B (Bore)*	2.500
C	7.375
E	1/2
F (Normal Size)*	7
H	2 3/8
JJ	3/16
K	1/4
L (Chamfer)	1/16
N	3/8
NN	7/16
P	3/8
Q	3 3/4
T	13/16
X	1 1/4
Y	7 1/8
Z	6 7/8

ClydeUnion Pumps swapped out the thrust bearing with one that has greater thrust pad flexibility, enabling the thrust collar to operate correctly. As the replacement had the same design envelope as the original, there was no need for further modification.
