CASE STUDY

## RE-ENGINEERING OF THIRD PARTY PUMPS IMPROVES EFFICIENCY

Industry: Oil & Gas - downstream

API Type: BB5

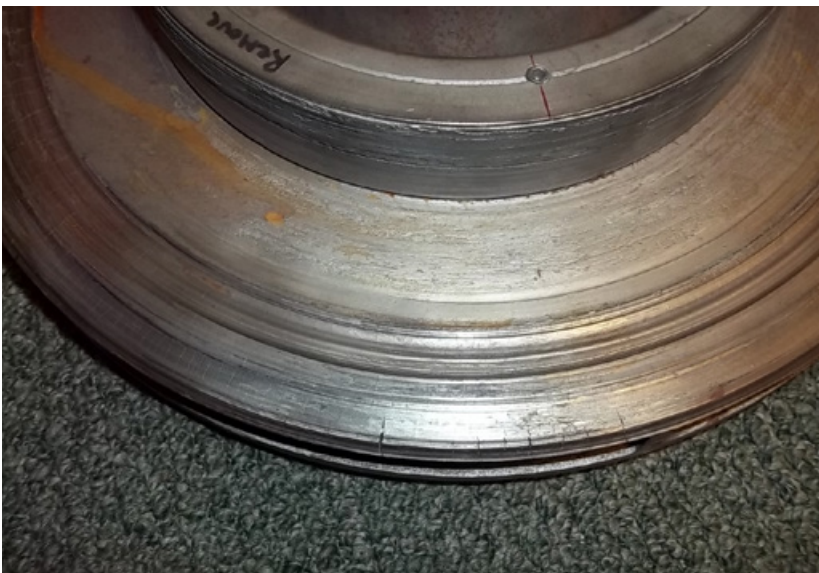
Damaged impeller

Using state-of-the-art, non-contact, laser technology, Celeros Flow Technology was able to obtain highly accurate scan data of the damaged impeller and diffuser parts. The pumps exhibited signs of wear that were caused by inherent design flaws and our Aftermarket Services team sought ways of eliminating these fundamental design issues as part of the pump overhaul.

The Celeros FT solution has impellers that shrink fit to the shaft, reducing the likelihood of the impeller working loose or making the shaft bow. The new shaft design also makes assembly and disassembly of the rotor and pump easier.

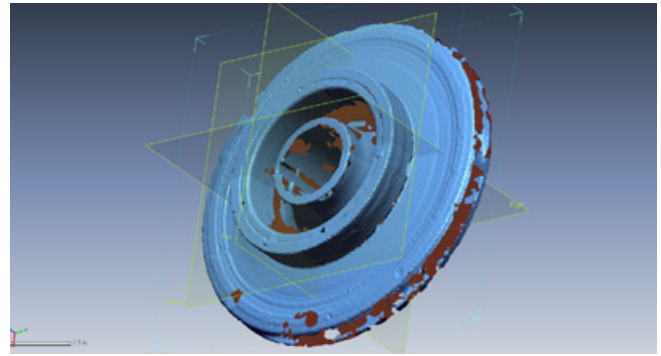
3D scan of damaged impeller

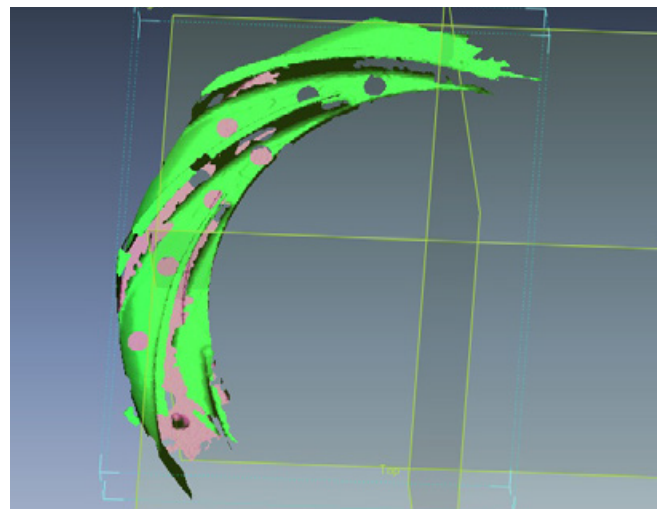
3D scan of damaged diffuser
