CASE STUDY

## PUMP DESIGN UPGRADE IMPROVES MTBR FOR PAPER MILL

- Causes of impeller and shaft damage investigated
- Operational safety margins restored
- Improved MTBR

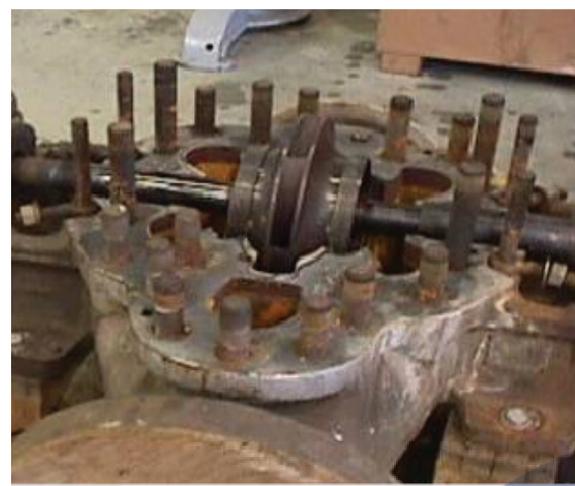
the rotor

ClydeUnion Pumps found that the pump’s shaft was sheared under the impeller fit and there was a crack in the hub of the impeller at the keyway. The impeller wear rings were exhibiting 360° rubbing and some case damage had been caused by a combination of erosion and rubbing of the impeller.

Analysis of the pump was undertaken to determine the cause of the broken shaft under the impeller. Calculations of the first and second dry natural frequencies were done on the original pump. The results showed that the pump’s first and second dry natural frequencies were running quite close to the x 1 and x 2 running speed. Factoring in the effects of the worn packing and wear rings, it was clear that the pump was operating at critical speed.

The new design was based on increasing the margin between the first natural frequency and the running speed. ClydeUnion Pumps achieved this by changing the shaft diameter, the distance between bearings, and the distance from the radial bearing and coupling. The throat bushing was also upgraded to a graphite/metal alloy and installed with mechanical seals.
