CASE STUDY

PUMP OVERHAUL PREVENTS DOWNTIME AT AMINE PLANT

Category: Service center overhaul

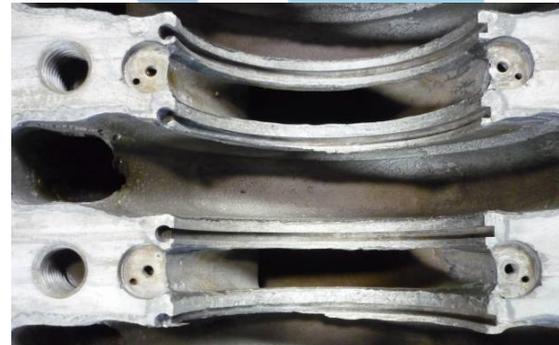
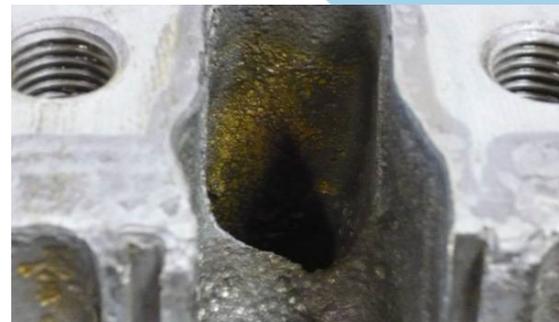
Pump casing

The pump casing was sent to our Service Center in Annecy, France without the rotor, because the rotor parts were too damaged to be repaired. The pump casing showed high erosion/corrosion marks, leading to loss of material: particularly around the casing wear ring landings and volute tongues.

Our solution was to carry out weld repairs on all the damaged parts of the pump casing and to supply a new rotor. This was not straightforward, due to the limited accessibility of certain parts and the need for perfect control of intensity and temperature during the welding. A non-controlled weld procedure can lead to a change in metal properties, and increase stress and strain on the casing.

- Cleaning and full dimensional inspection of all returned components
- Machining of eroded parts (Figure 1)
- Refurbishment of parts by weld deposition, heat treatment and re-machining of pump casing (Figure 2 and 3)
- Grounding plates added
- Re-assembly with a new rotor
- Hydrostatic and performance tests
- Clean down and paint

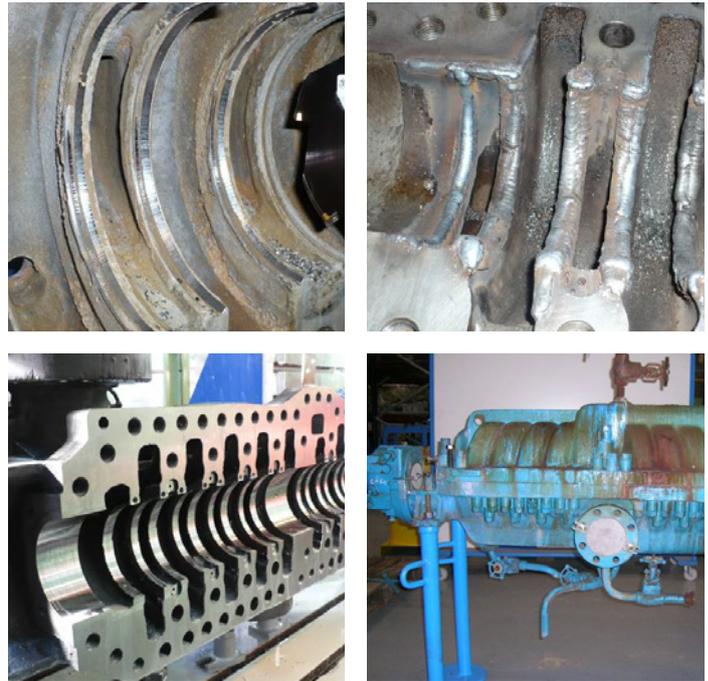
The customer operates 2 DVMX pumps for a Diethyl Amine (DEA) pumping process. The DEA process is very aggressive towards steel materials and the pump currently in operation was showing worrying signs of wear (collapse of characteristic and efficiency). The spare pump was out of service. Following several failed attempts at overhauling the unit by a competitor, the customer asked ClydeUnion Pumps, a Celeros Flow Technology brand, to overhaul the spare pump in the shortest time possible, so it could be re-installed to avoid any loss of production.

DVMX 3.4.9 10 stages pump before repair
