CASE STUDY

## IN SITU CORROSION REPAIR TO PUMP KEEPS DESALINATION PLANT OVERHAUL ON TRACK

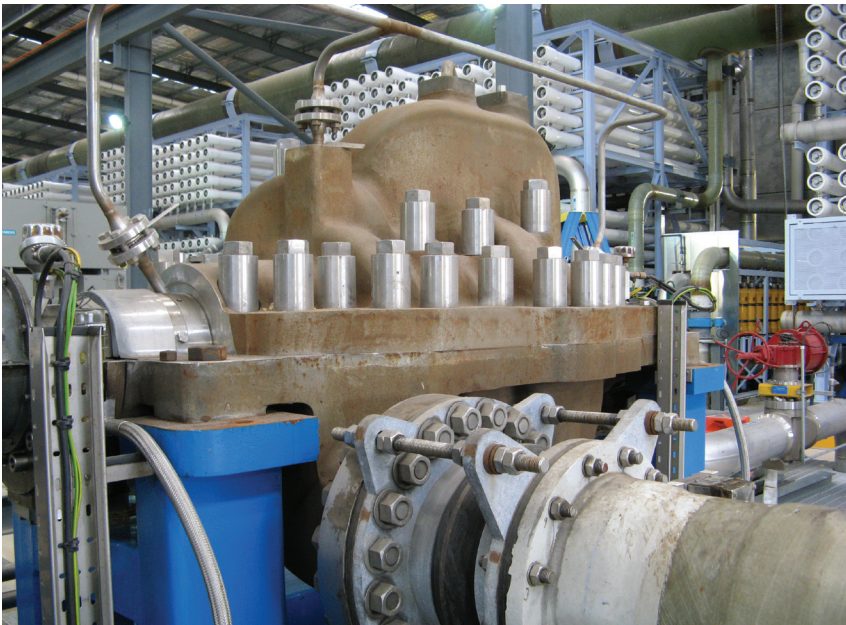
Pump installed at site

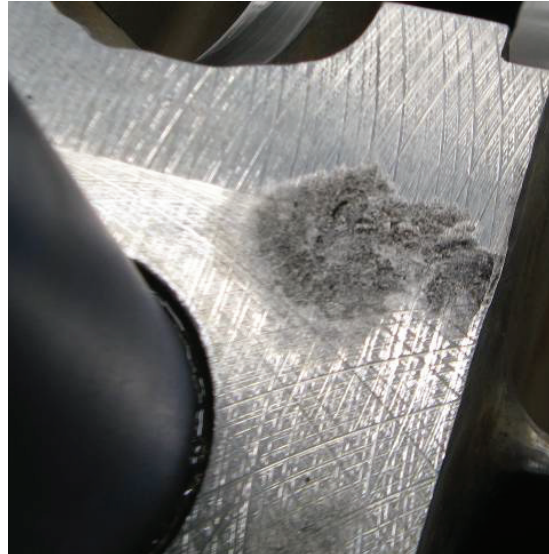
The customer had a replacement rotating element to swap out and a full set of replacement bushes ready to go. However, when the top half casing was removed crevice corrosion was apparent on the gasket face. The two regular methods of either replacing the casing or weld repairing it would significantly delay the overhaul.

The original pump casing material of Duplex Stainless Steel was selected for a less onerous fluid than was actually found at site. The customer was advised to upgrade any future spares to Super Duplex Stainless Steel, which has a higher pitting resistance equivalent number (PREN) value and is therefore more resistant to crevice corrosion than the original material.

Figure 2 – crevice corrosion on split flange

To address the immediate problem, ClydeUnion Pumps undertook a detailed investigation. This revealed that the damage to the casing did not significantly break into the hydraulic passage area, so use of a metal filler compound was an acceptable interim measure. The selection of the correct metal filler for the application was critical to ensure it would withstand the corrosive nature of the warm seawater and the high pressures exerted onto the flange face during normal operation.

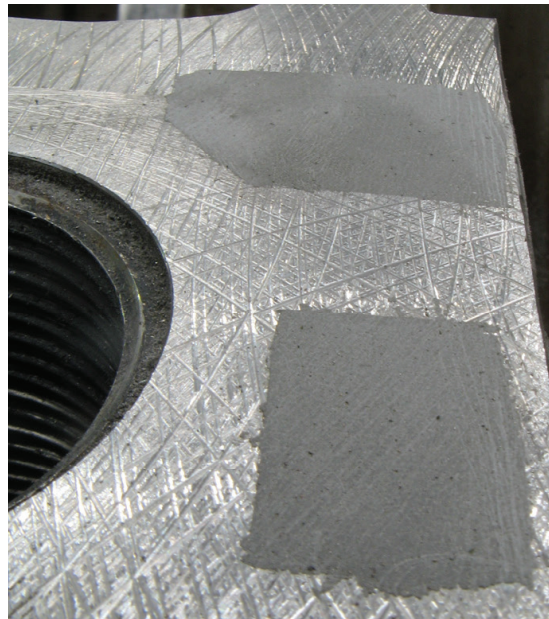
Figure 3 – finished repaired surface

The repair method used by ClydeUnion Pumps meant that the pump casing could remain in position and this significantly reduced the repair time of the casing. (It took two days to complete the work, including cure time for the filler.) This meant that the unit could be rebuilt and commissioned within the ten-day turnaround.
