CASE STUDY

FILTERING OUT PREMATURE PUMP SEAL FAILURES IMPROVES MTBO

- Mechanical seal failures averted
- Filter changes possible without stopping production
- MTBO improved from three to 18 months

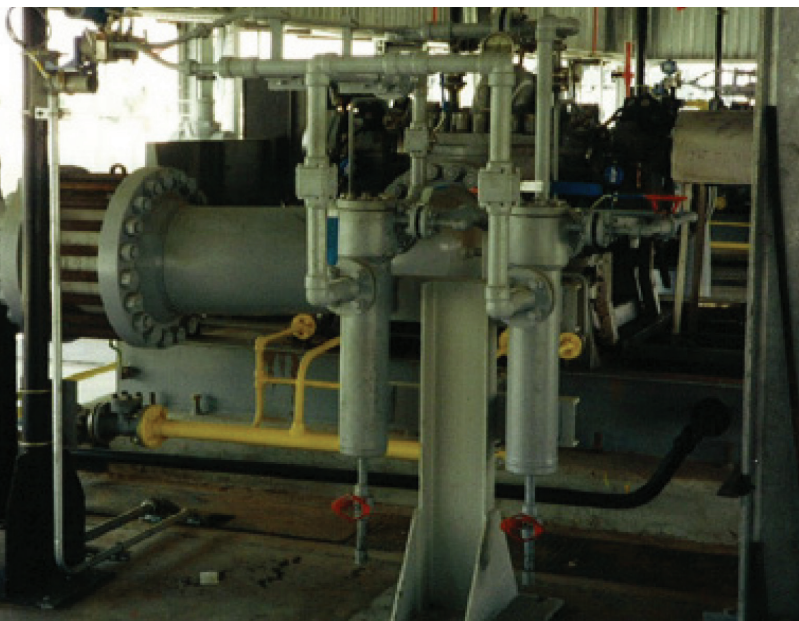
Improved filtration system for mechanical seal

A gas extraction plant in Algeria suffered continual production problems due to failure of mechanical seals on its BB1 and BB3 gas pumping packages, despite the use of very hard materials for the stationary and rotating seal rings (silicon carbide / carbon). Investigation revealed that the mechanical seal faces were being damaged due to the presence of solid particles in the pumped liquefied gas, despite the presence of a filter at the pump's suction. The filtration system was satisfactory for all other parts of the pump except the mechanical seals.

The aftermarket team at ClydeUnion Pumps designed, manufactured and installed a secondary filtration system to remove particles from the flush for the mechanical seals. It is equipped with two filter cartridges, so that filters can be replaced without having to stop the pump. The duplex filter system also features a pressure sensor with an alarm, which alerts when a cartridge is clogged. A valve system allows the clogged cartridge to be isolated and the fluid to flow through the other clean cartridge without disrupting production.
