CASE STUDY

MATERIALS UPGRADE TO BOILER FEED PUMP DELIVERS ROI WITHIN 1 YEAR

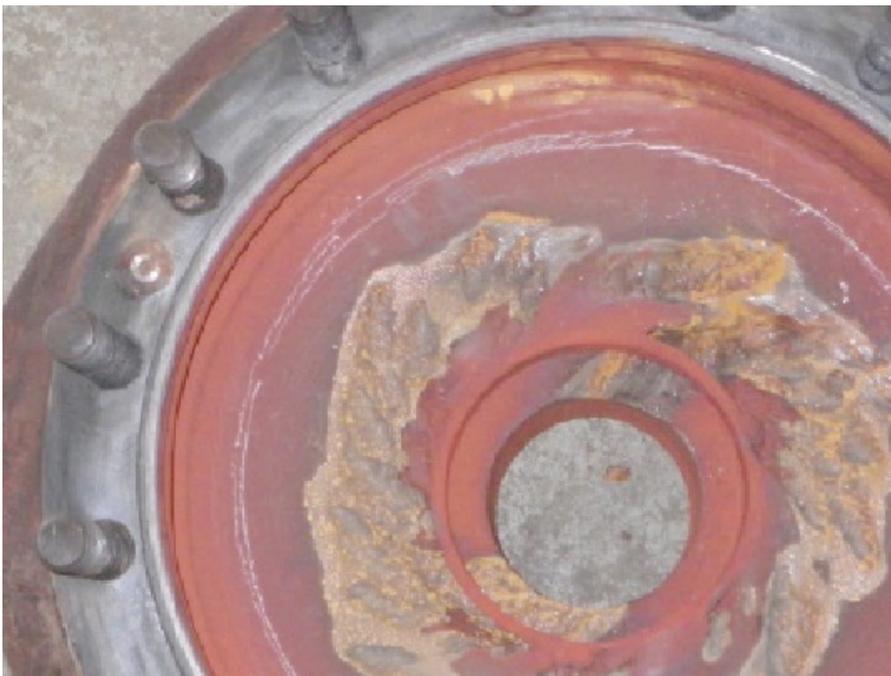
Damaged casing

Inspection of the failed components revealed damage consistent with the use of carbon steel in hot, low conductivity water service. The type and random nature of the damage along with service conditions were key factors in making this determination, which was later supported by an independent metallurgical examination.

This failure mechanism involves erosion and corrosion of the metal, where the protective oxide scale at the surface is dissolved, and the underlying metal is removed due to the velocity of the water. Generally speaking, carbon steel casings must be avoided in boiler feed applications where the water temperature is greater than 200°F, and the conductivity of the water is less than 20 µmhos/cm. In these cases, damage will occur primarily in high velocity areas.

For this boiler feed water application ClydeUnion Pumps recommended the replacement of the carbon steel components with 12% chrome (CA-6NM), 316 stainless, and 400 series stainless steels (CA-6NM and CA-15), which are not affected by this failure mechanism.

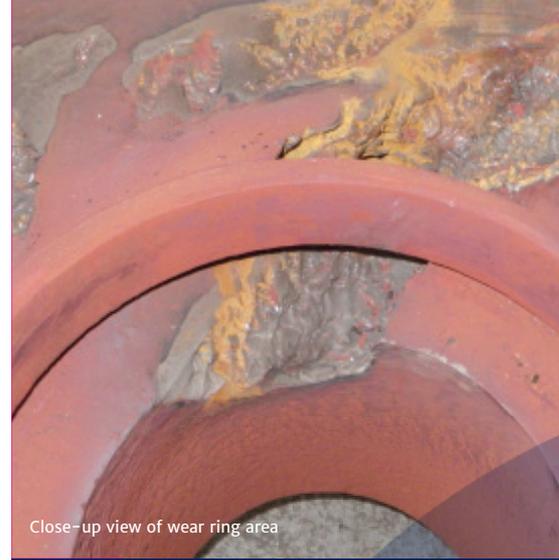
Close-up view of wear ring area
