ControlEdge PLC

ControlEdge RTU

Release 174.1

ControlEdge Builder Software Change Notice

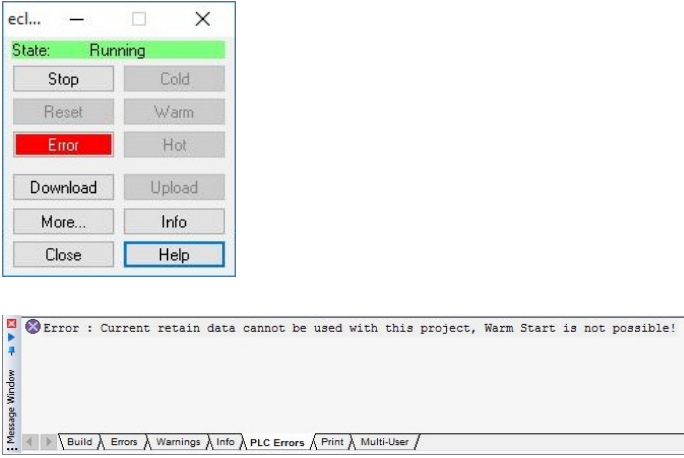
1-AKZIH2J	<p>Description: Occasionally, when you download a project online to a controller, you will encounter the situation that the program of a non-redundant controller with I/O modules and data log configured will be stopped.</p> <p>Recovery: Power cycle the controller.</p> <p>Workaround: None</p>	ControlEdge PLC and ControlEdge RTU
1-AUD7BUZ	<p>Description: After users select retain property of variables and download the project, an error that "Warm start is not possible" displays in message window when you do switchover. However, the controller can still perform warm start. The error message is invalid.</p>

<p>Recovery: None</p> <p>Workaround: None</p>	ControlEdge RTU
RELMMTOCE-63	<p>Description: An error that says "WARNING: LC CHECKSUM MISMATCH" appears on the LM Detail Status Display. You can safely ignore this error.</p>	ControlEdge PLC

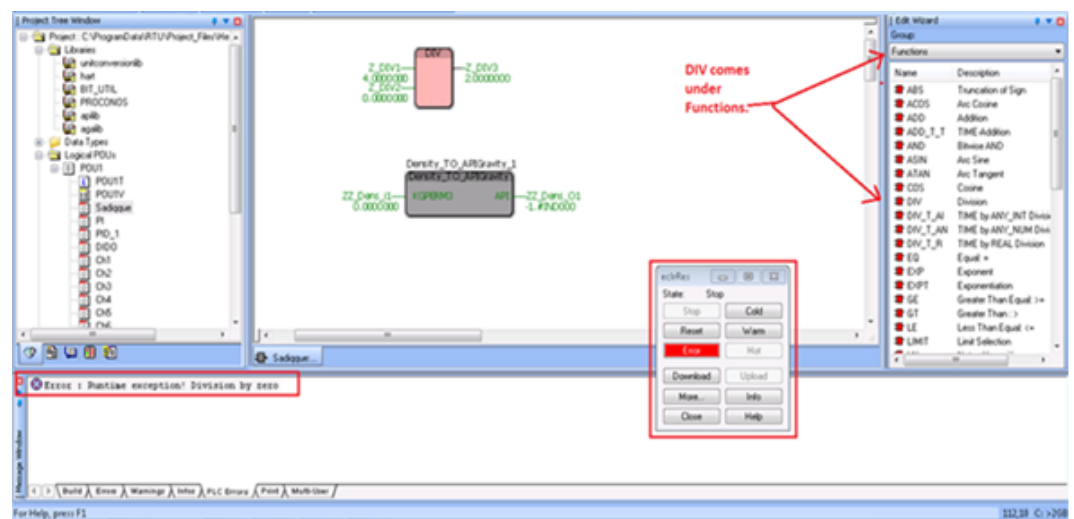
Avoiding Divide by Zero Error in the Program

Abstract: In an IEC -61131-3 programming environment like ControlEdge Builder, it is possible to configure a program that is prone to have divide by zero errors. If this occurs at runtime, the controller will stop executing the program. To view the error, connect ControlEdge Builder to the controller and open the Project Control Dialog in the IEC Programming workspace. The error button will be red. On clicking it, an error, “Runtime exception! Division by zero” is shown in the “PLC Errors” tab of the message window.

Consequences: If the divide by zero situation occurs in a running program, the controller will stop executing. All output channels will go to the failsafe state as configured in the program. The likelihood of this occurring is dependent on the programming and if the divisor/s in question are ever likely to return exactly zero.

Recovery: Cold reboot the controller. This can be performed from the builder or by removing and restoring power to the controller.

Workaround: When using a divide function in the IEC61131-3 program, ensure appropriate error checks are included to avoid the divide by zero situation from occurring.
