CASE STUDY

## REDESIGN AND TESTING PROVES NEW COATING WILL EXTEND PUMP SERVICE LIFE FOR CUSTOMER

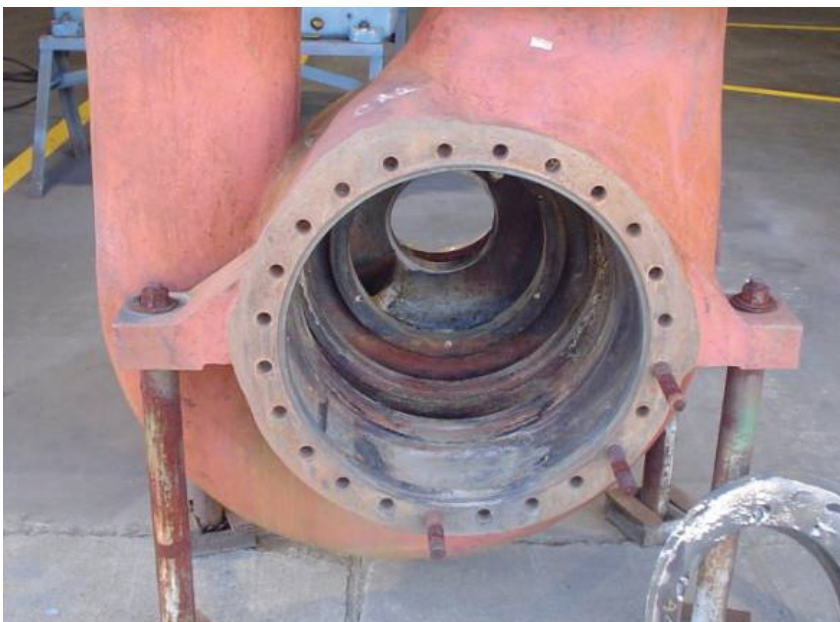
Casing with wear plate

Design changes to the pump were made to accommodate testing prior to and after the addition of the chosen coating. In addition, the replaceable wear plates were eliminated from the new design and traditional wear parts (including case and impeller wear rings) were made integral with the covers and impeller.

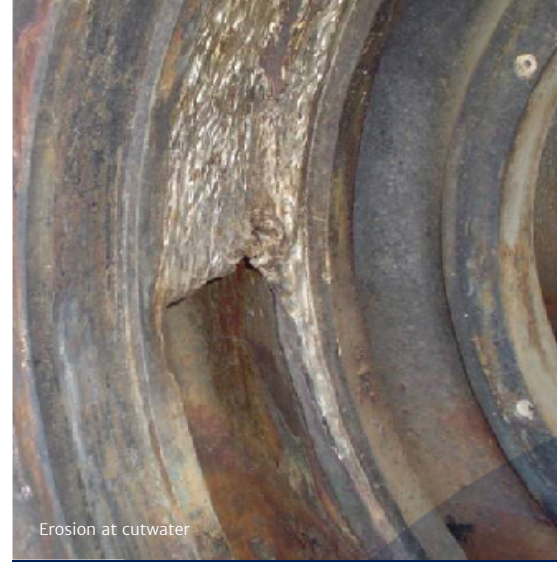
This returning customer had previously been impressed by our ability to upgrade two third party pumps by supplying “drop-in” replacements with protective coatings to internal wetted parts. While the two-year service life of the coating supplied had proved acceptable, the retired coated casings exhibited severe abrasion caused by catalyst fines.

Erosion at cutwater

The customer’s maintenance team was therefore interested in applying another coating type that would perform better in abrasive applications. They turned again to ClydeUnion Pumps for support.

The application of the preferred coating presented many challenges. The first requirement was to select materials that were suitable for cladding for the casing and impeller. The process for cladding includes a welding process, so it had to be suitable for a post weld heat treat process: otherwise there was a risk of cracking in the casing.

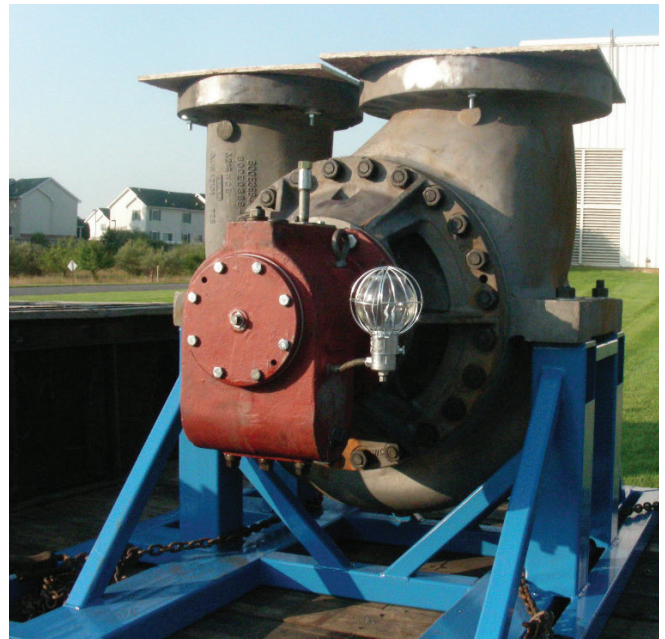
Completed pump

The redesign and testing performed by ClydeUnion Pumps proved that the preferred coating for abrasive applications could be applied to the customer's pumps. The overall service life of the pumps would therefore increase by 50%, from four years to six years – significantly reducing the total cost of ownership.
