CASE STUDY

RE-ENGINEERING OF PUMP PARTS PREVENTS PRODUCTION LOSSES AT BITUMEN PLANT

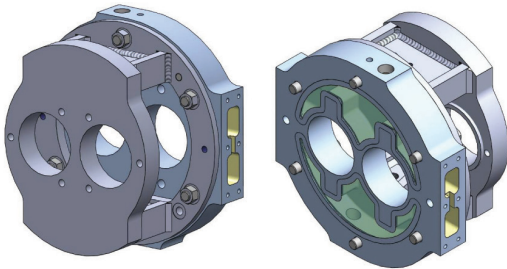
Purchase of specific cutting tools for machining of parts

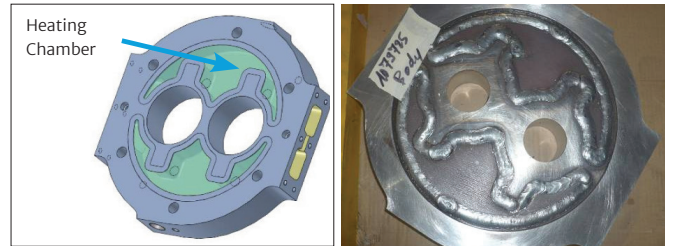
- Hydrostatic test of heating boxes
- Assembly of bearing housings with heating boxes to realise final machining of bores

Demonstrating the added value of working with a Celeros Flow Technology company, ClydeUnion Pumps proposed to create new mechanically welded bearing housings and heating boxes based on measurements taken on site. As well as controlling costs and delivering a solution on time, the re-design of these parts also allowed ClydeUnion Pumps to accommodate requirements formulated by the end user's maintenance team to improve the alignment of bearing housings on the pump casing. ClydeUnion Pumps developed the new designs and used computer-aided manufacturing techniques to make the new bearing housings and heating boxes. They also performed hydrostatic tests on the heating boxes prior to delivering the parts to the customer.
