CASE STUDY

SIMPLE SOLUTION CURES REPEAT PUMP SHAFT BREAKAGES AT OIL REFINERY

- Cause of premature failures identified
- Solution required no modification to pump
- Improved MTBR

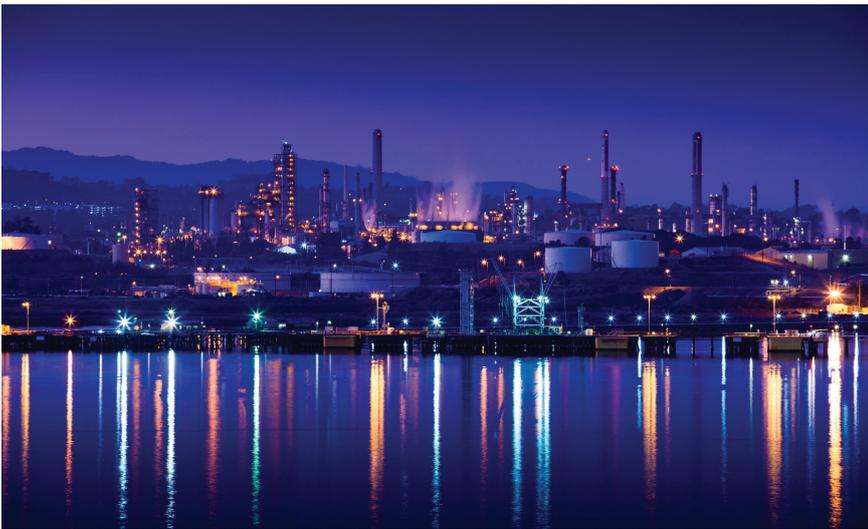
Refinery

A US oil refinery was experiencing issues with a barrel pump. They asked ClydeUnion Pumps to perform an upgrade and investigate the cause of numerous shaft breakages in the location of the thrust collar.

Thrust shaft breakages can occur for a number of reasons: improper shaft design, excessive thrust loading, excessive runout of the shaft and/or thrust collar, or poor materials specification. In this instance, the intrinsic design was the root cause. The internal levelling washer had seized, forcing the thrust collar to cycle the shaft until it failed.

ClydeUnion Pumps swapped out the thrust bearing with one that has greater thrust pad flexibility, enabling the thrust collar to operate correctly. As the replacement had the same design envelope as the original, there was no need for further modification.
