CASE STUDY

## RE-ENGINEERING OF THIRD PARTY PUMPS IMPROVES EFFICIENCY

Industry: Oil & Gas - downstream

API Type: BB5

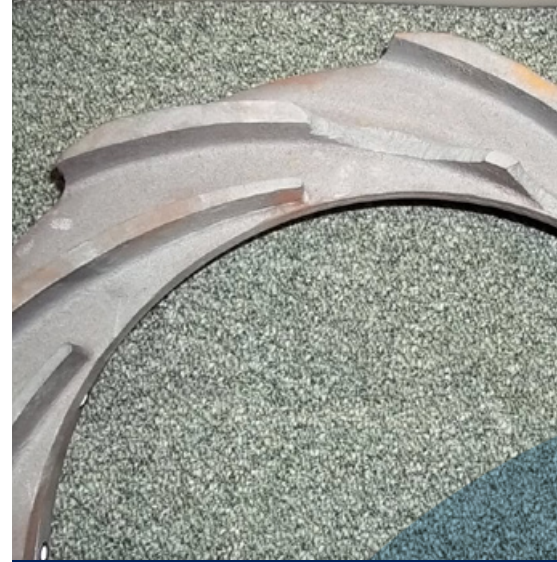
Damaged impeller

Using state-of-the-art, non-contact, laser technology, Celeros Flow Technology was able to obtain highly accurate scan data of the damaged impeller and diffuser parts. The pumps exhibited signs of wear that were caused by inherent design flaws and our Aftermarket Services team sought ways of eliminating these fundamental design issues as part of the pump overhaul.

For example, the original impeller assembly was slip fitted and held in place with a single nut. The rotor had to be disassembled in order to reassemble the complete pump, making it virtually impossible to duplicate the runouts and balance. The balance piston also had a tendency to come loose if the shaft nut was not properly tightened. These factors can lead to excessive runouts and a bowed shaft due to the faces and bores of all components not being exactly square and true.

The Celeros FT solution has impellers that shrink fit to the shaft, reducing the likelihood of the impeller working loose or making the shaft bow. The new shaft design also makes assembly and disassembly of the rotor and pump easier.

Thanks to our inhouse engineering expertise, we have been able to improve the suction characteristics to reduce cavitation damage and increase overall efficiency. The use of stronger and more corrosion-resistant materials has also improved the service life of the components, which also improves the overall Mean Time Between Failures (MTBF).
