CASE STUDY

FILTERING OUT PREMATURE PUMP SEAL FAILURES IMPROVES MTBO

- Mechanical seal failures averted
- Filter changes possible without stopping production
- MTBO improved from three to 18 months

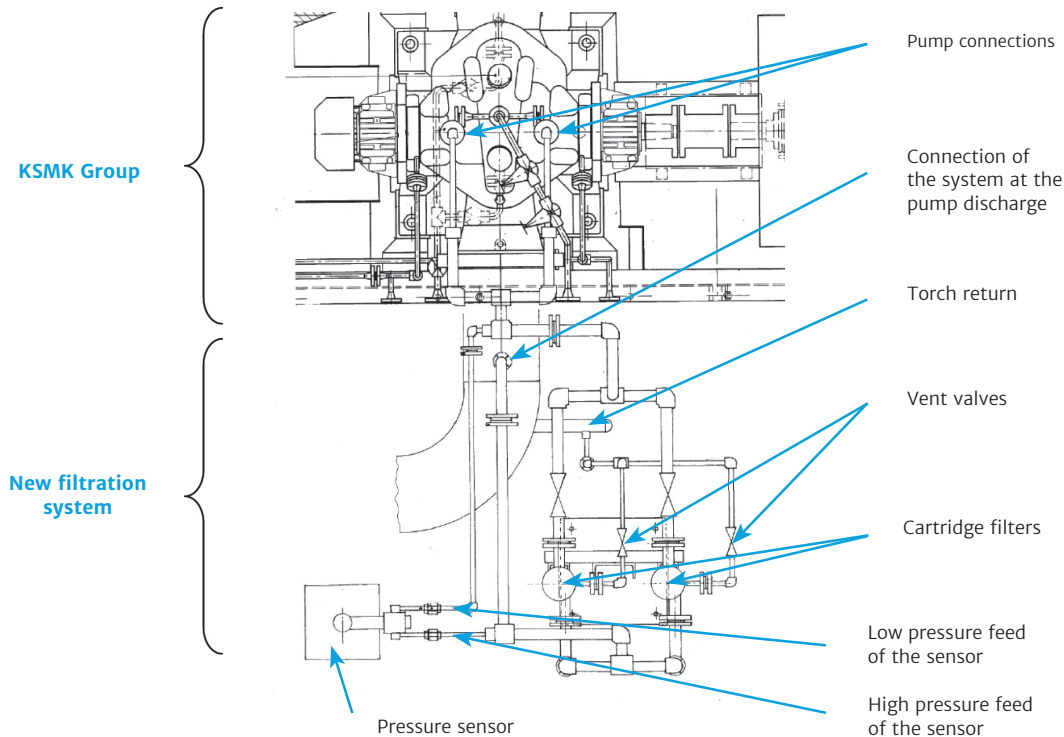
Improved filtration system for mechanical seal

The aftermarket team at ClydeUnion Pumps designed, manufactured and installed a secondary filtration system to remove particles from the flush for the mechanical seals. It is equipped with two filter cartridges, so that filters can be replaced without having to stop the pump. The duplex filter system also features a pressure sensor with an alarm, which alerts when a cartridge is clogged. A valve system allows the clogged cartridge to be isolated and the fluid to flow through the other clean cartridge without disrupting production.
